# **EXHIBIT 3**

## **(Part 2 of 2)**

*M.Delvin & Associates, Inc. Project No. 2009.01  
Diamante, Cabo San Lucas*

*Project Review and Site Visit Report  
November 2015*

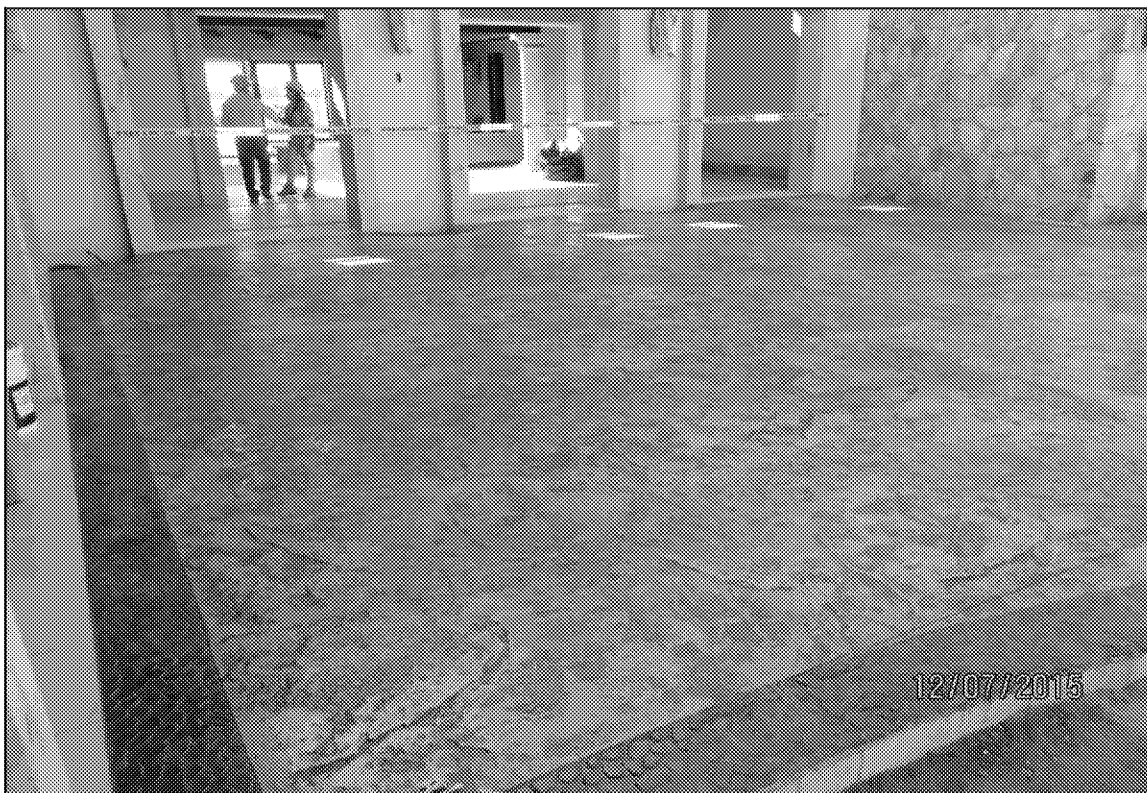
**Photograph 21:** GV 4: The patterned concrete entry drive was recently cast.

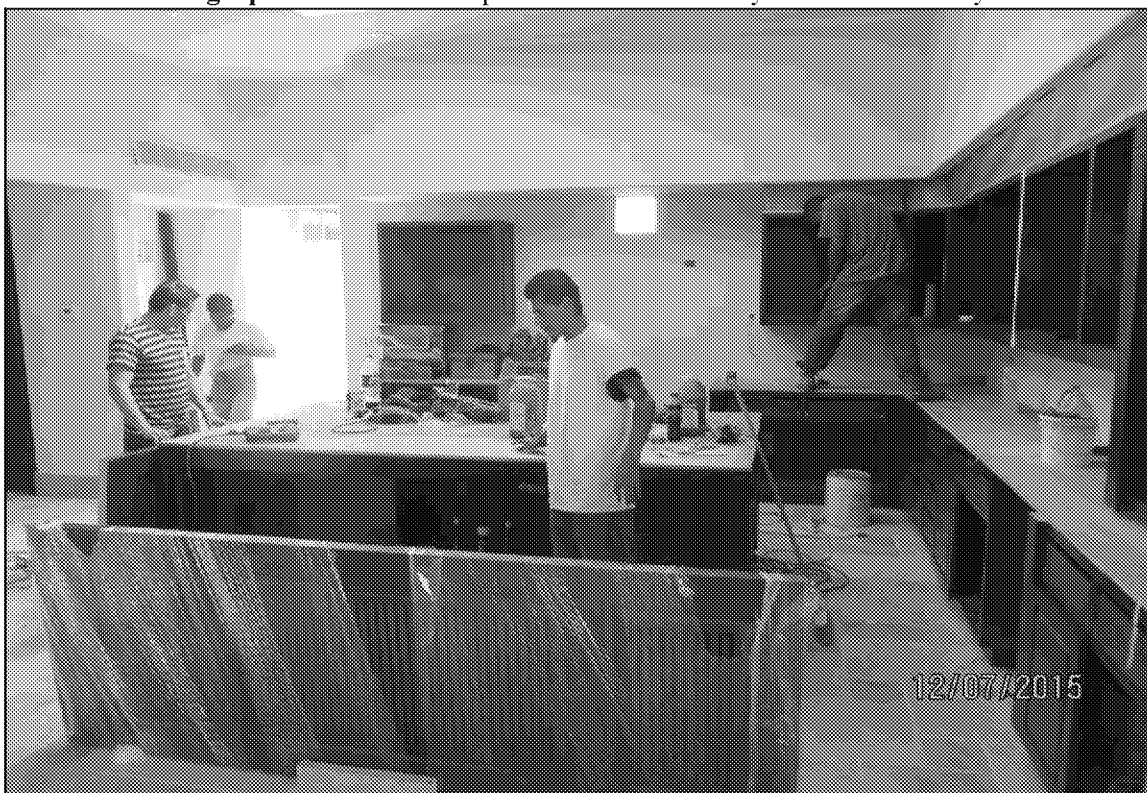
**Photograph 22:** GV 4: Carpentry construction underway includes kitchen cabinets.

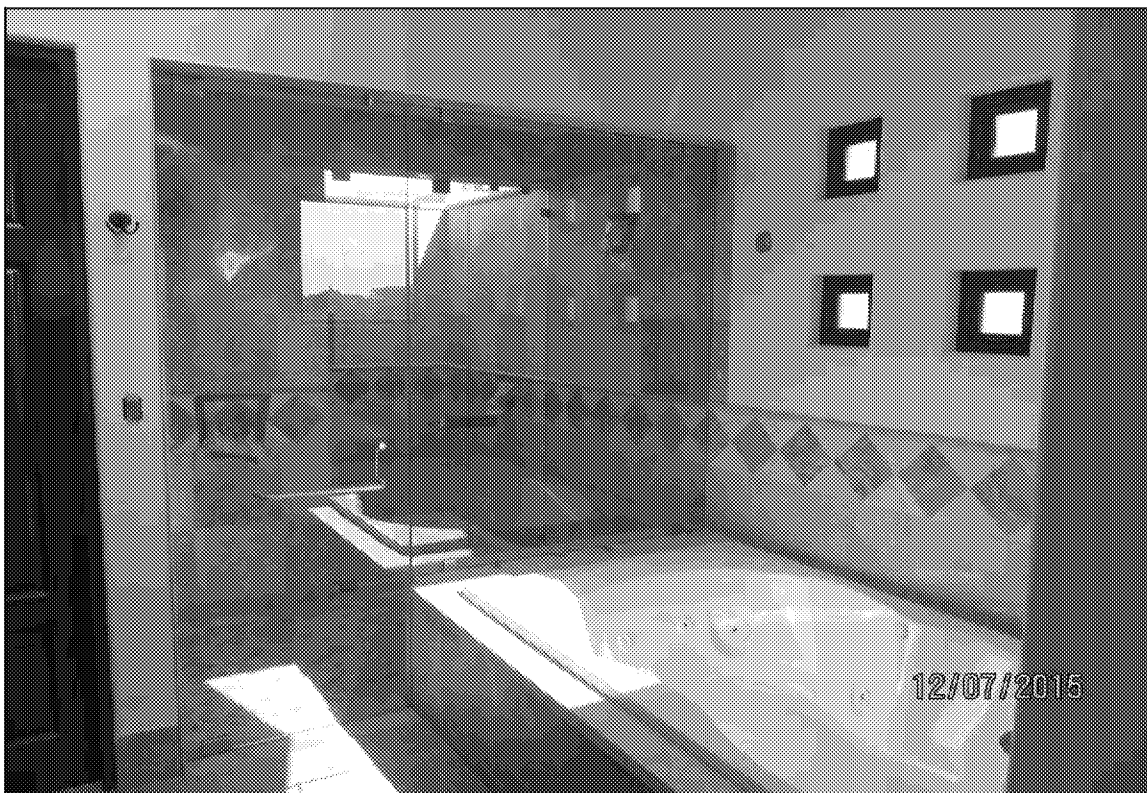
**Photograph 23:** GV 4: The floor and wall tile, and bathroom fixtures are complete.

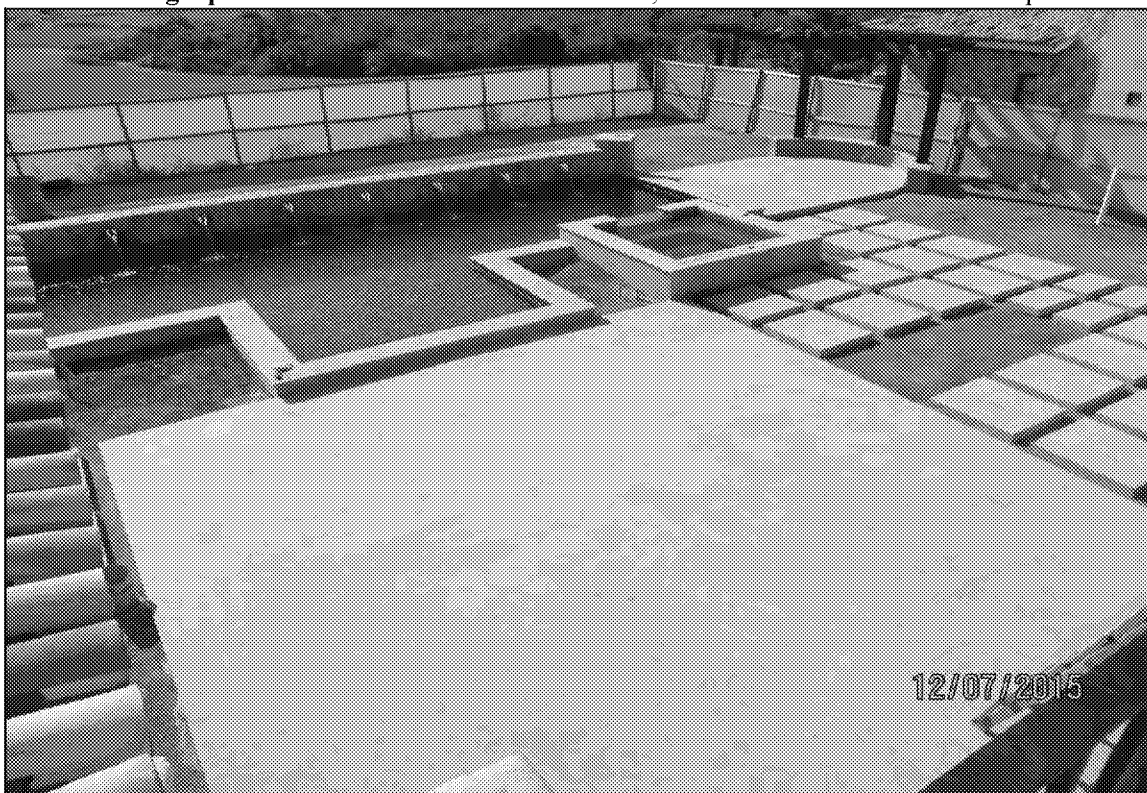
**Photograph 24:** GV 4: The pool and deck have been constructed.

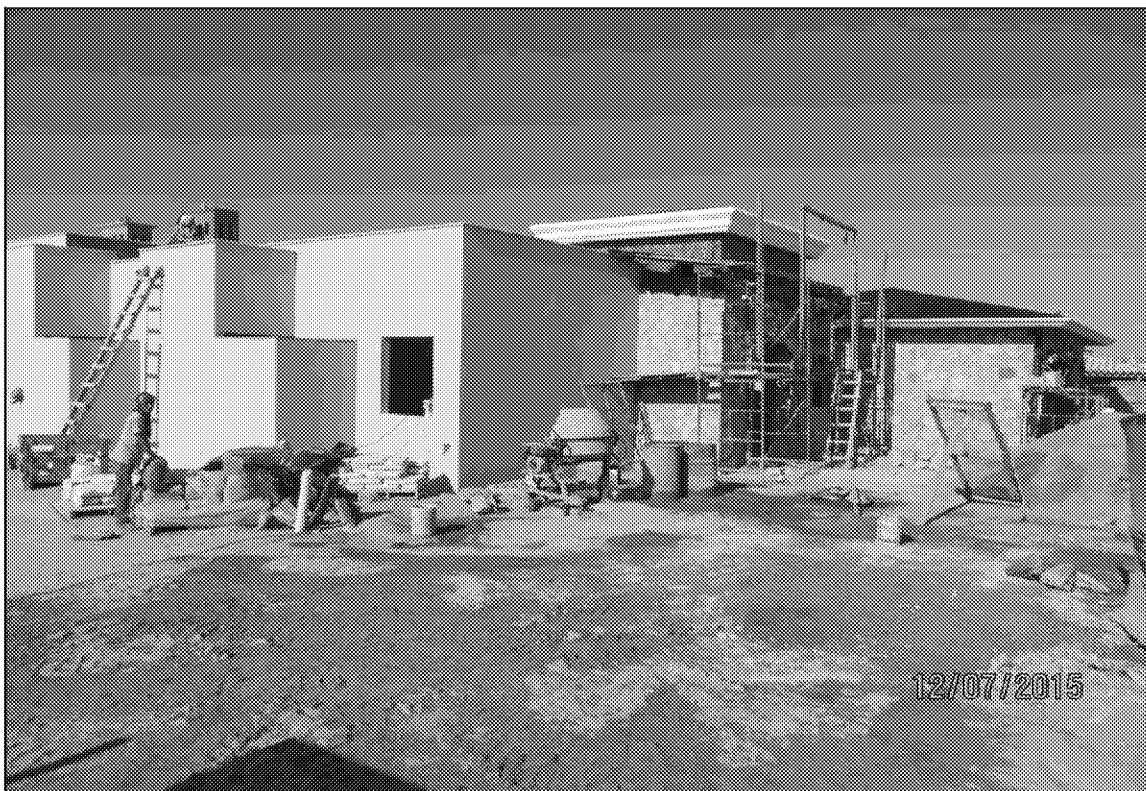
**Photograph 25:** GV 15: Building structure is relatively complete and exterior finishes are being placed.

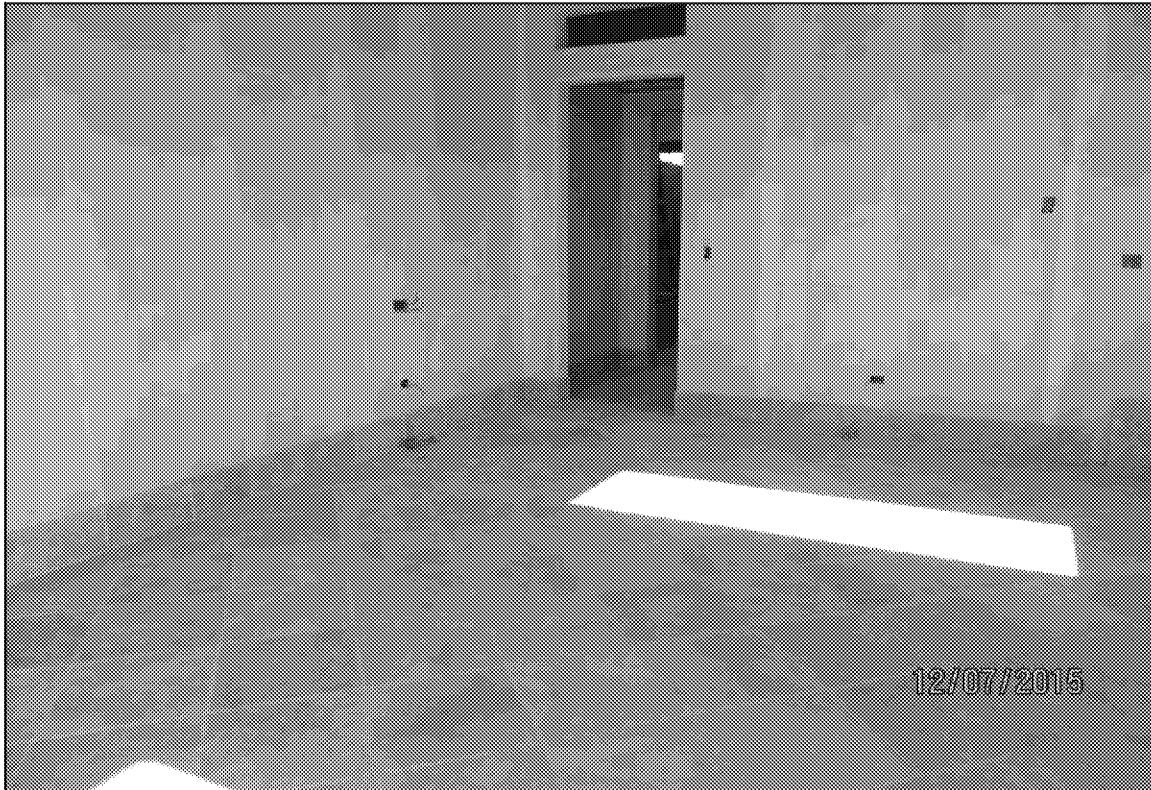
**Photograph 27:** GV 15: Floor tile has been placed in many areas, and interior plaster coating and primer paint coating has been placed.

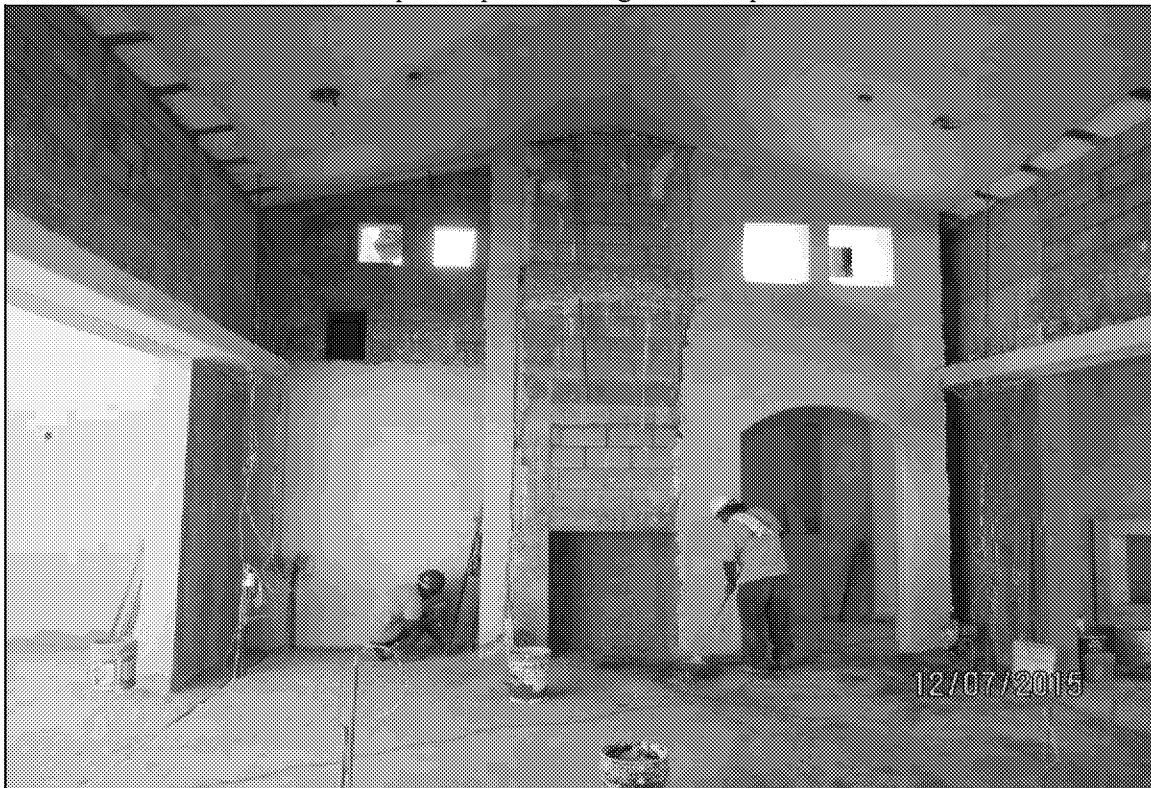
**Photograph 28:** GV 15: Plaster coating in areas which do not receive other finishes have been placed within the great room.

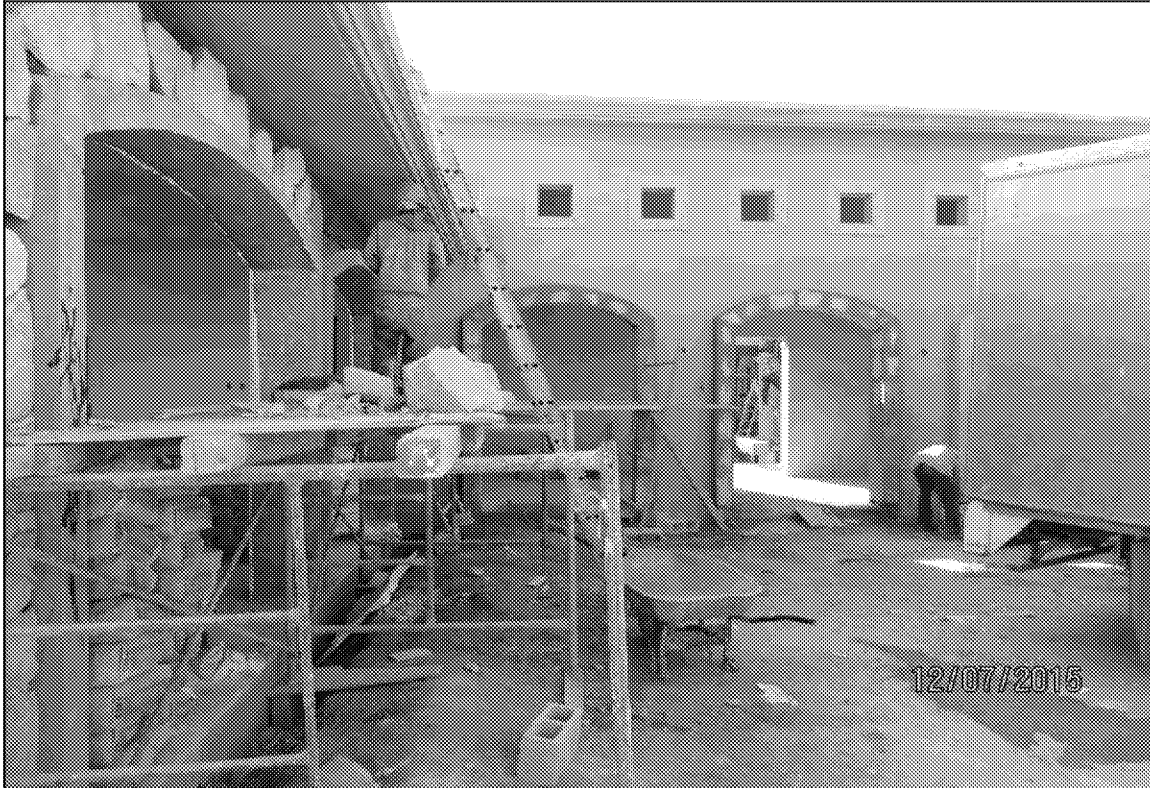
**Photograph 29:** GV 21: The building structure is relatively complete and exterior finishes are being placed.

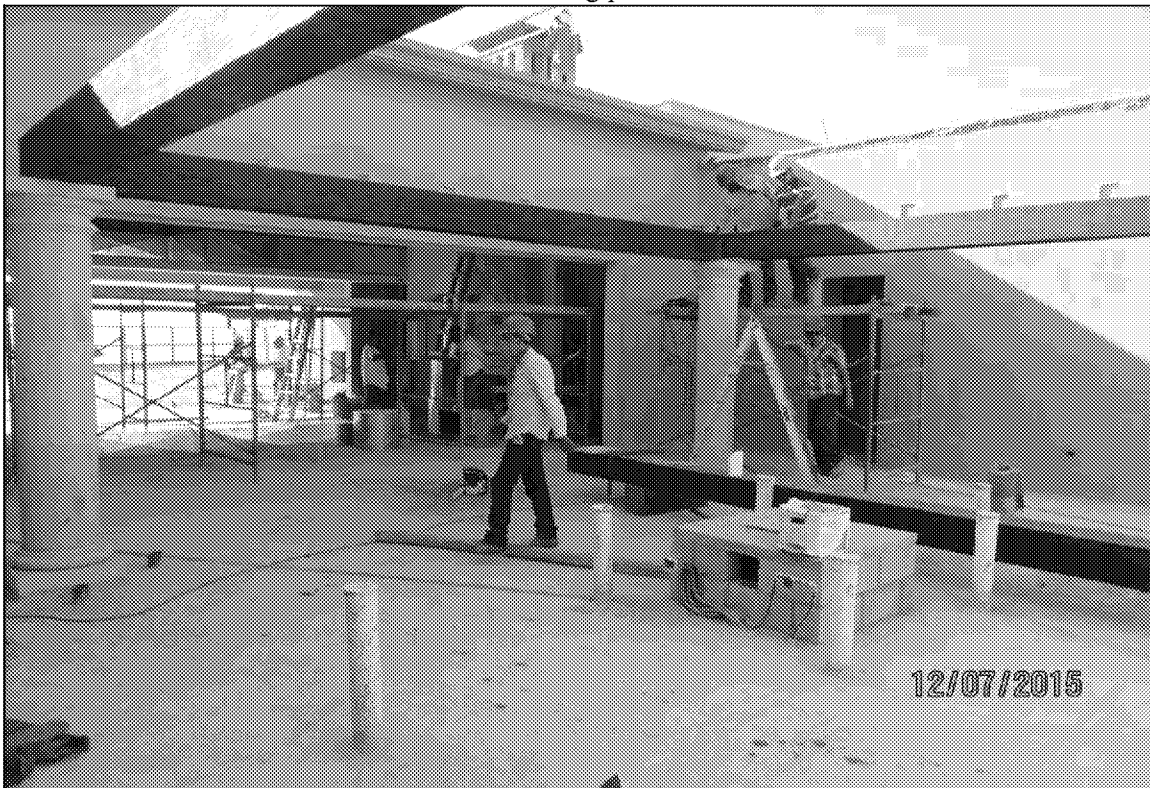
**Photograph 30:** GV 21: Carpentry construction of the main courtyard roof support beams is underway.

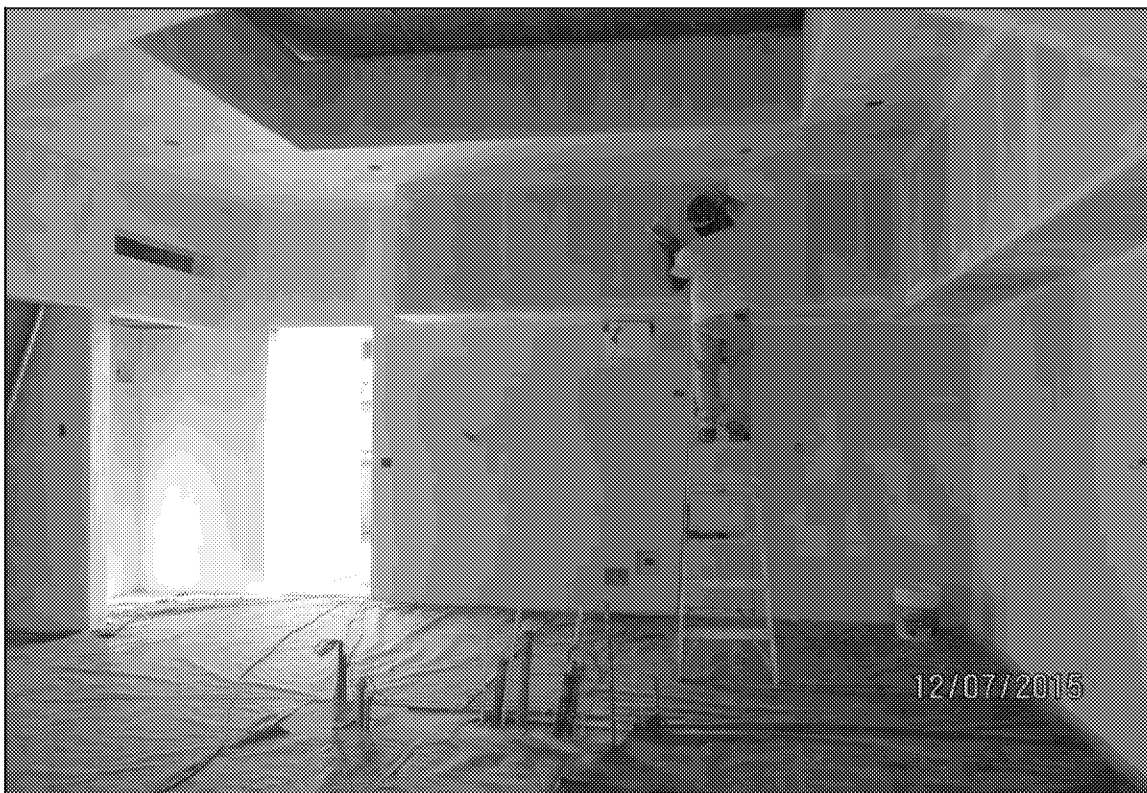
**Photograph 31:** GV 21: The gypsum board soffits within the kitchen are being completed.

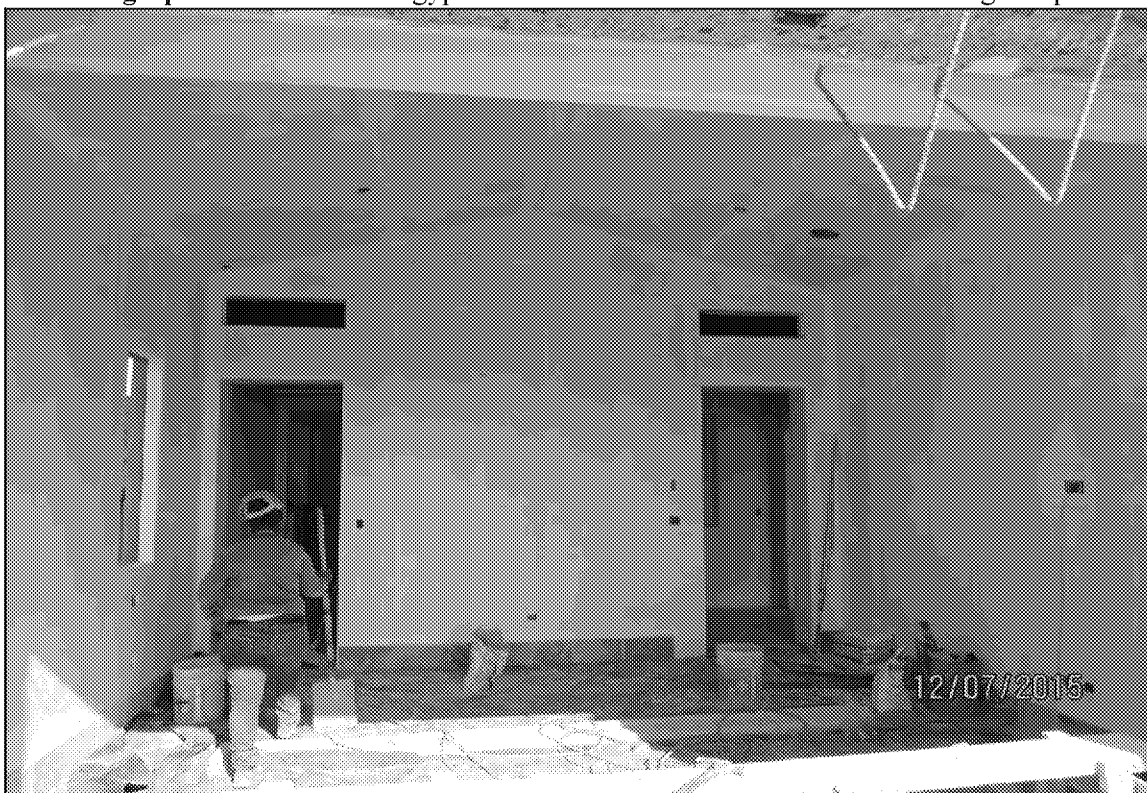
**Photograph 32:** GV 21: Floor tile is complete and primer paint coating has been completed in the master bedroom.

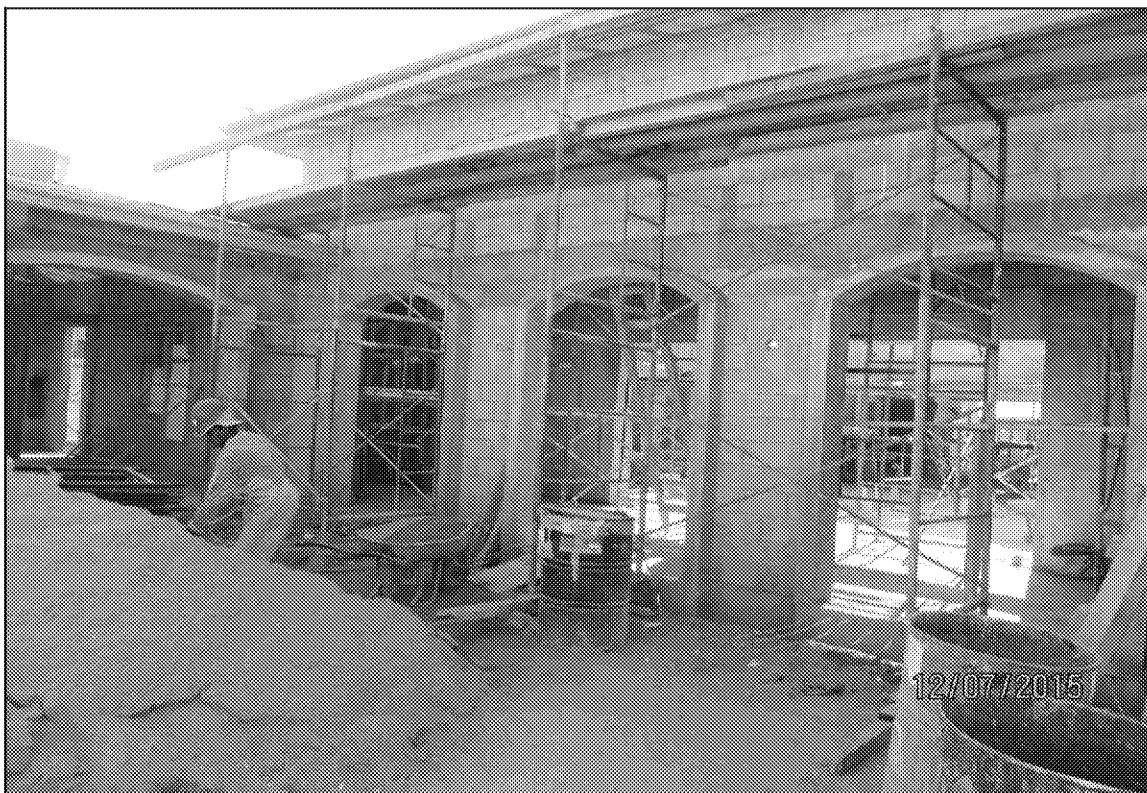
**Photograph 33:** GV 26: Building structure is nearing completion and exterior scaffolding has been erected to place the cement plaster coating.

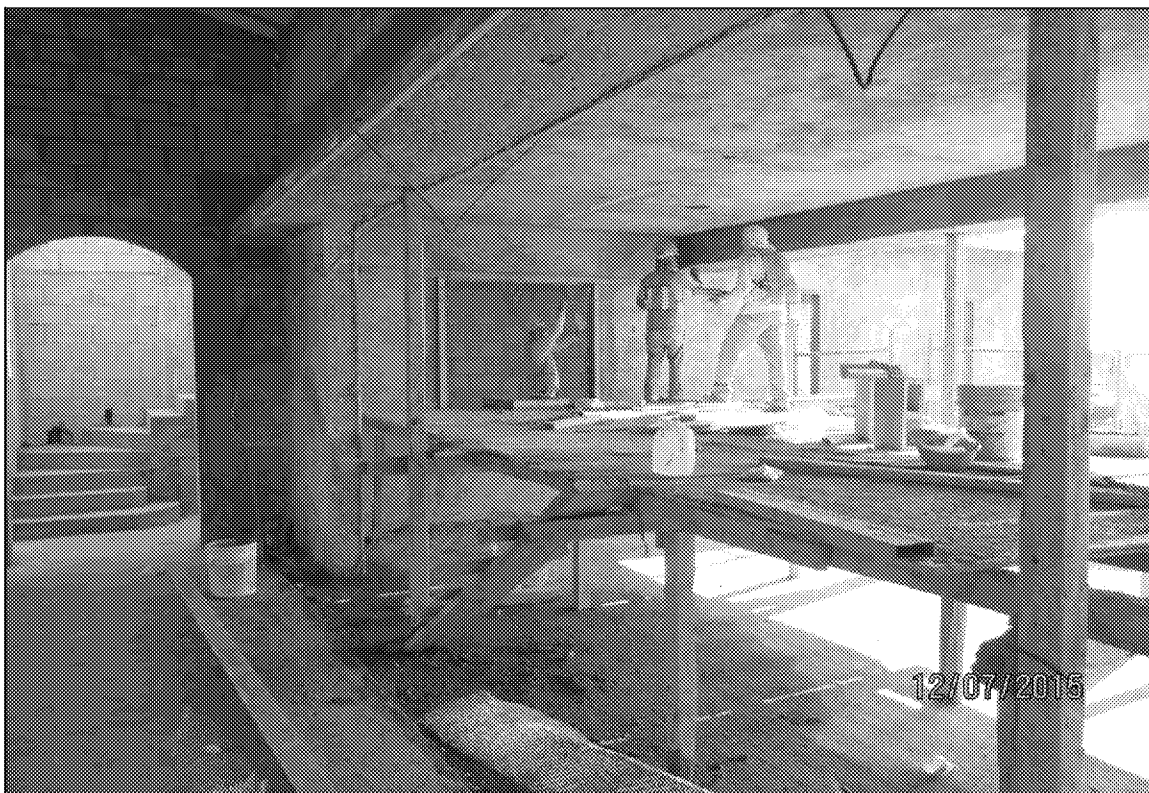
**Photograph 35:** GV 26: Work platform has been constructed for construction of the overhead soffit at the back patio.

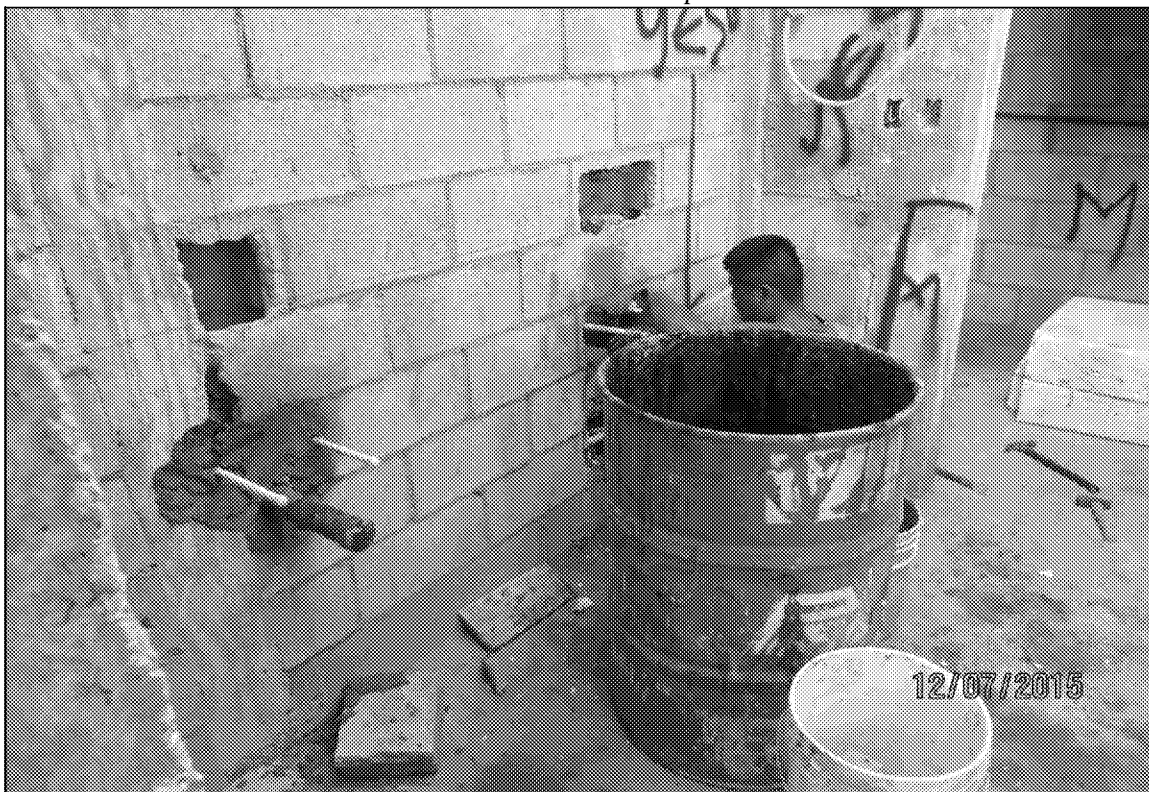
**Photograph 36:** GV 26: Plumbing line installation is underway within bathroom walls.

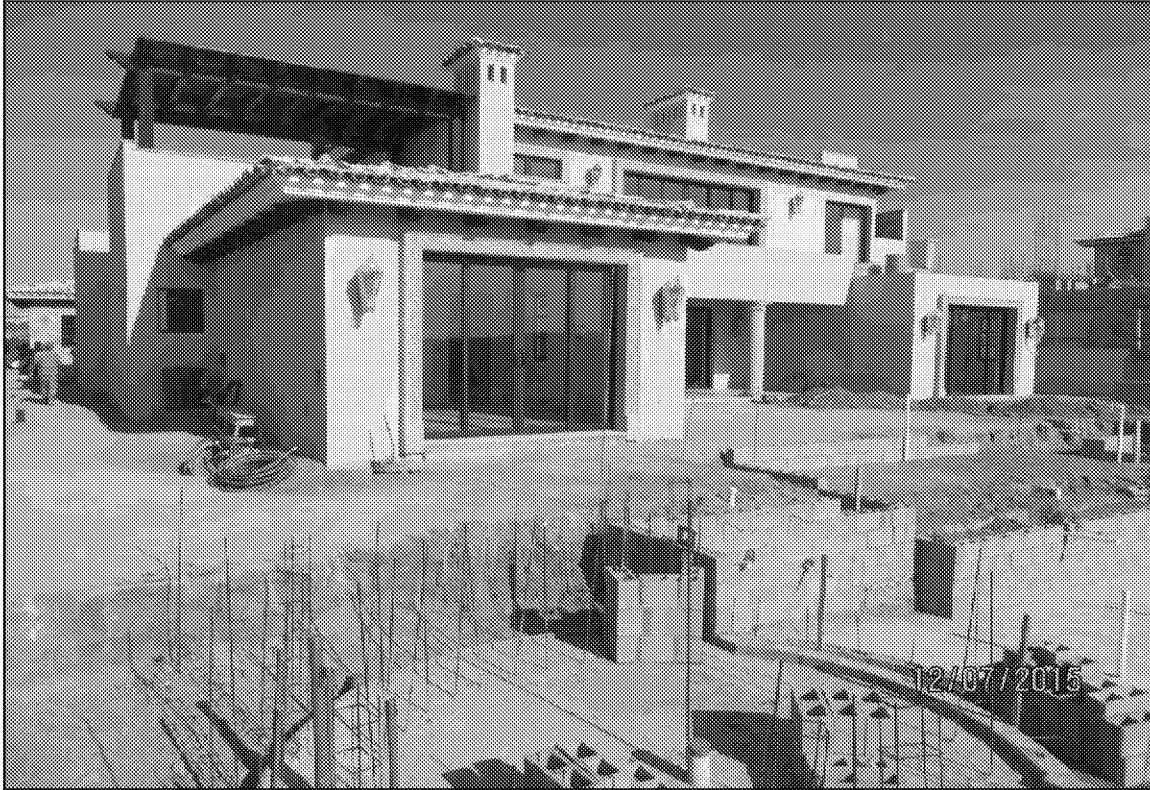
**Photograph 37:** GV 27: The exterior finishes are relatively complete and the pool structure construction is underway.

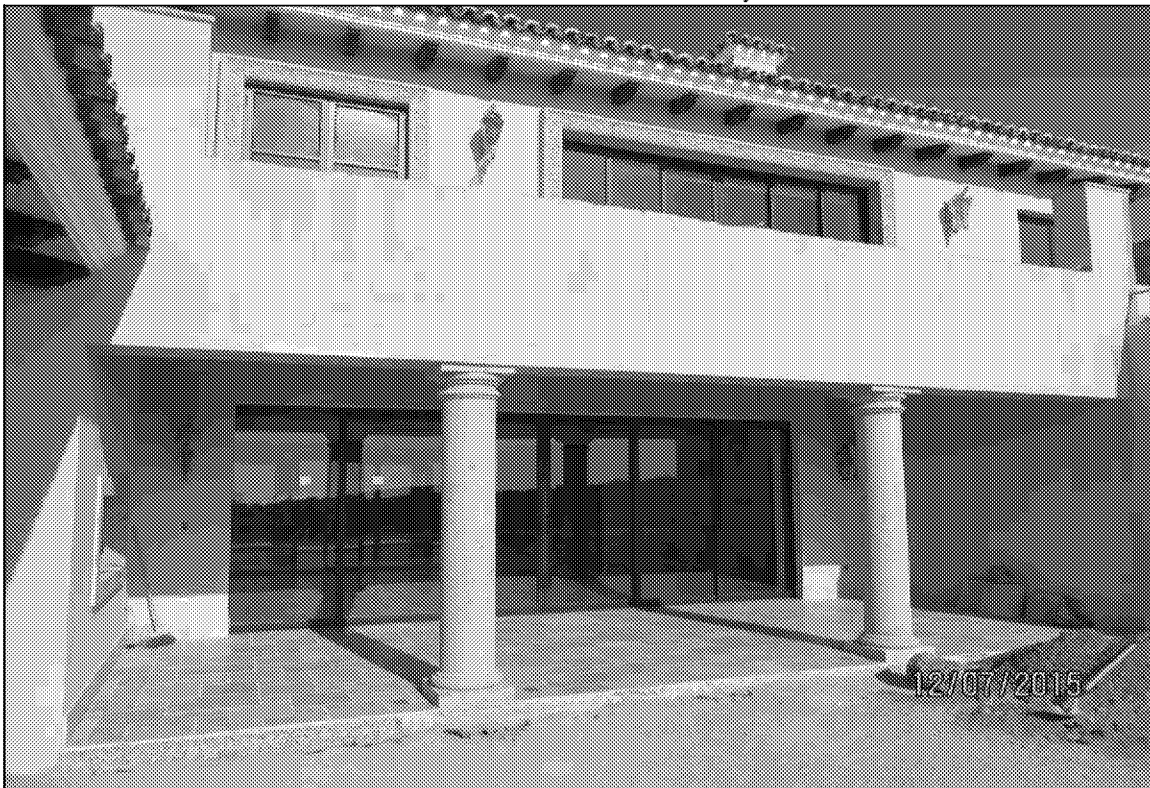
**Photograph 38:** GV 27: The covered patio tile is complete but the patio concrete of the pool deck has not yet been cast.

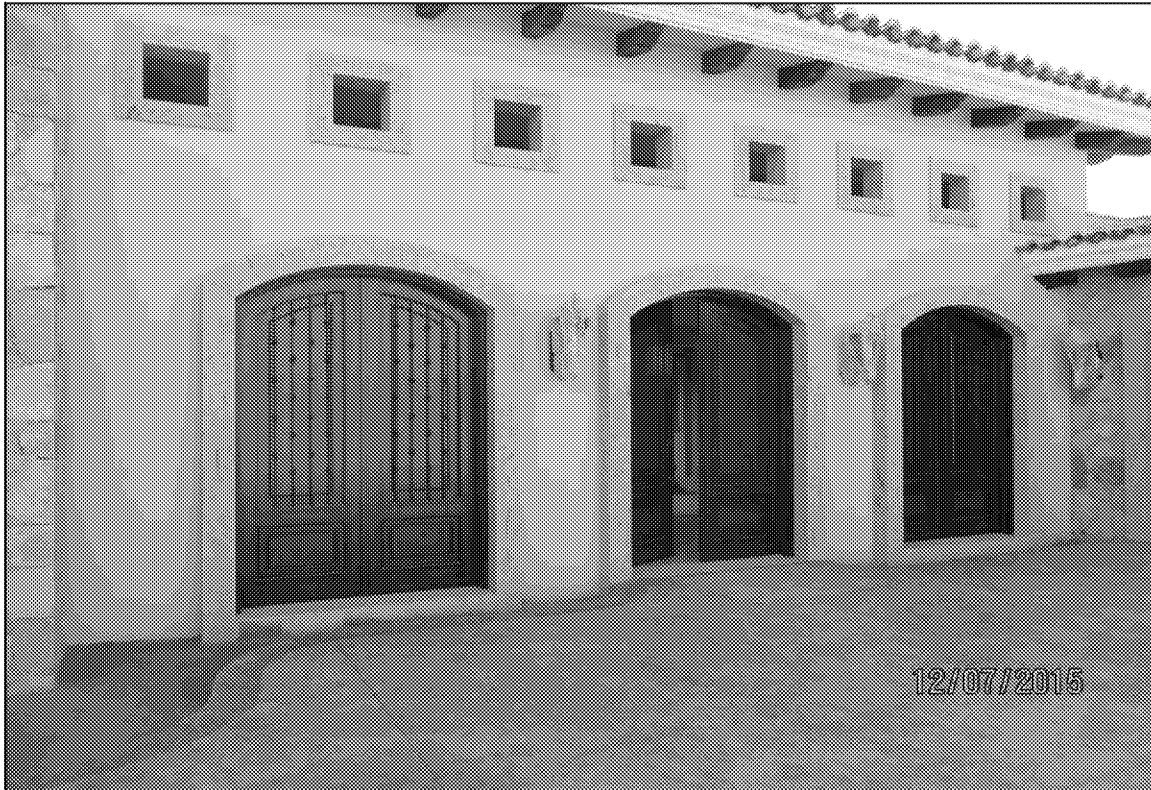
**Photograph 39:** GV 27: The entry doors are complete and the patterned concrete driveway has been cast.

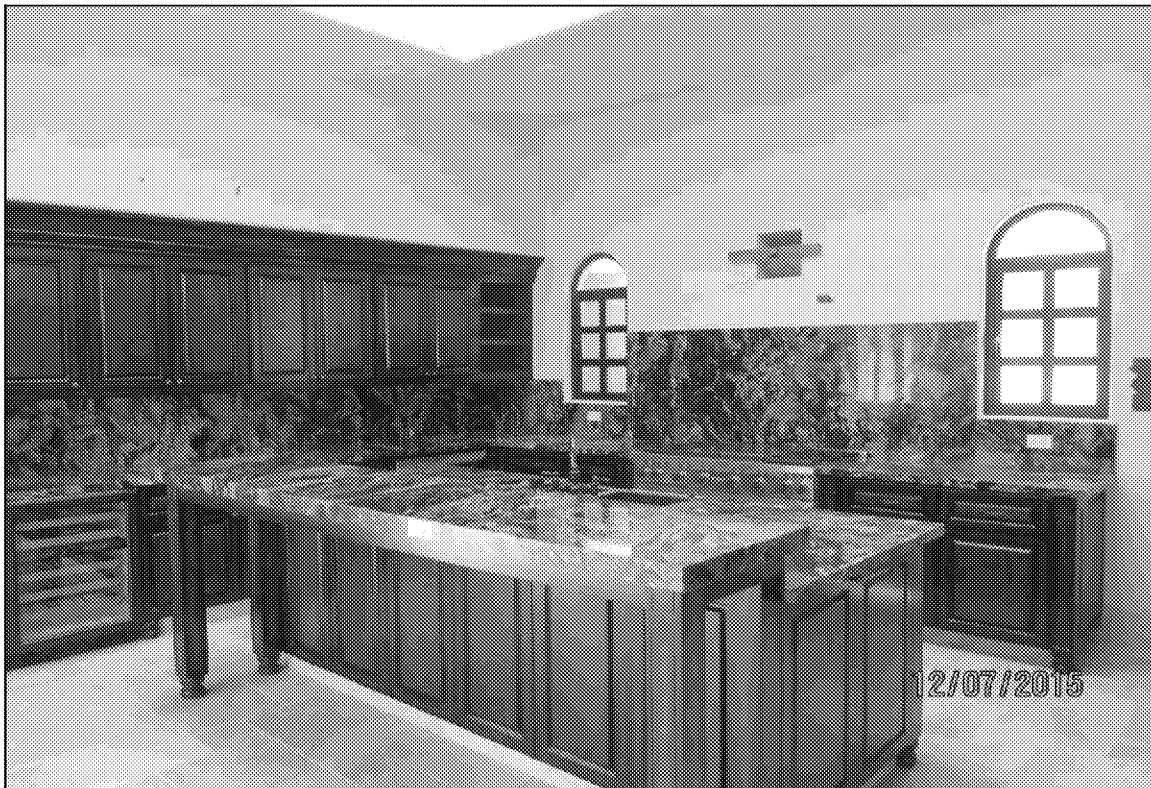
**Photograph 40:** GV 27: The kitchen is complete with cabinets, appliances, and countertops. The custom range hood has not yet been installed.

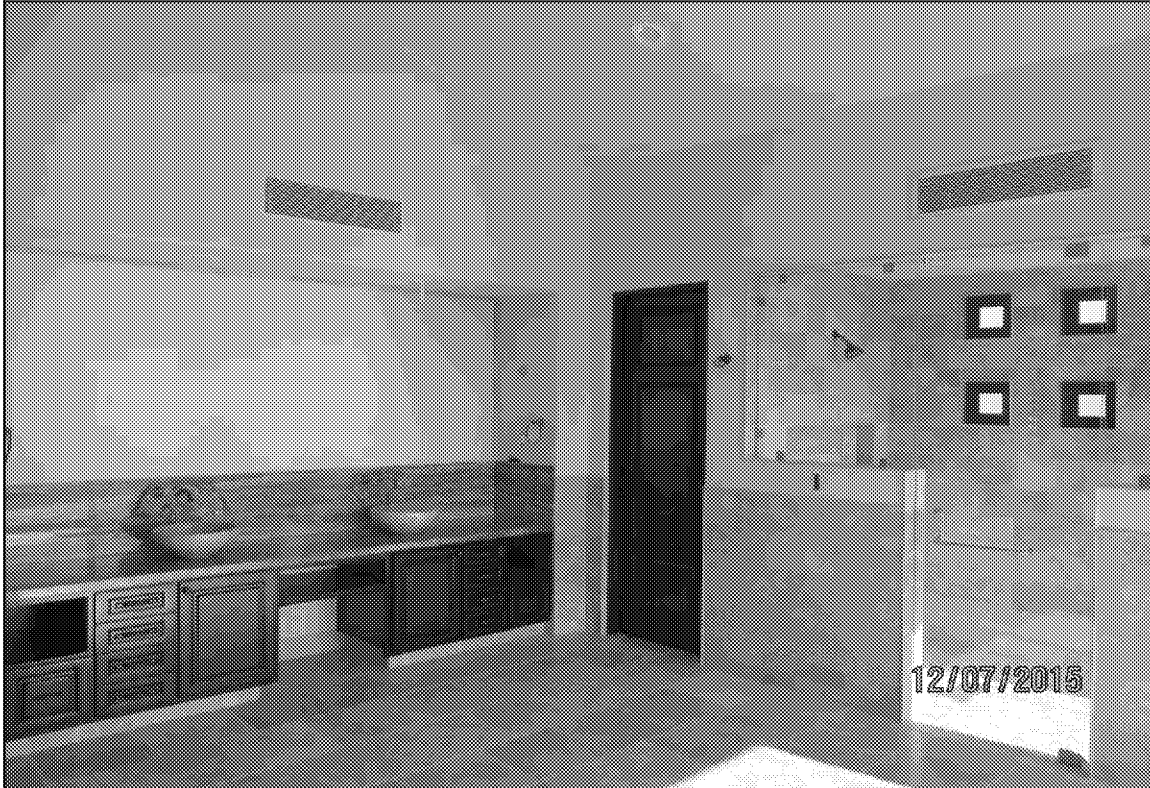
**Photograph 41:** GV 27: The second floor master suite bathroom is complete with finishes and bathroom equipment.

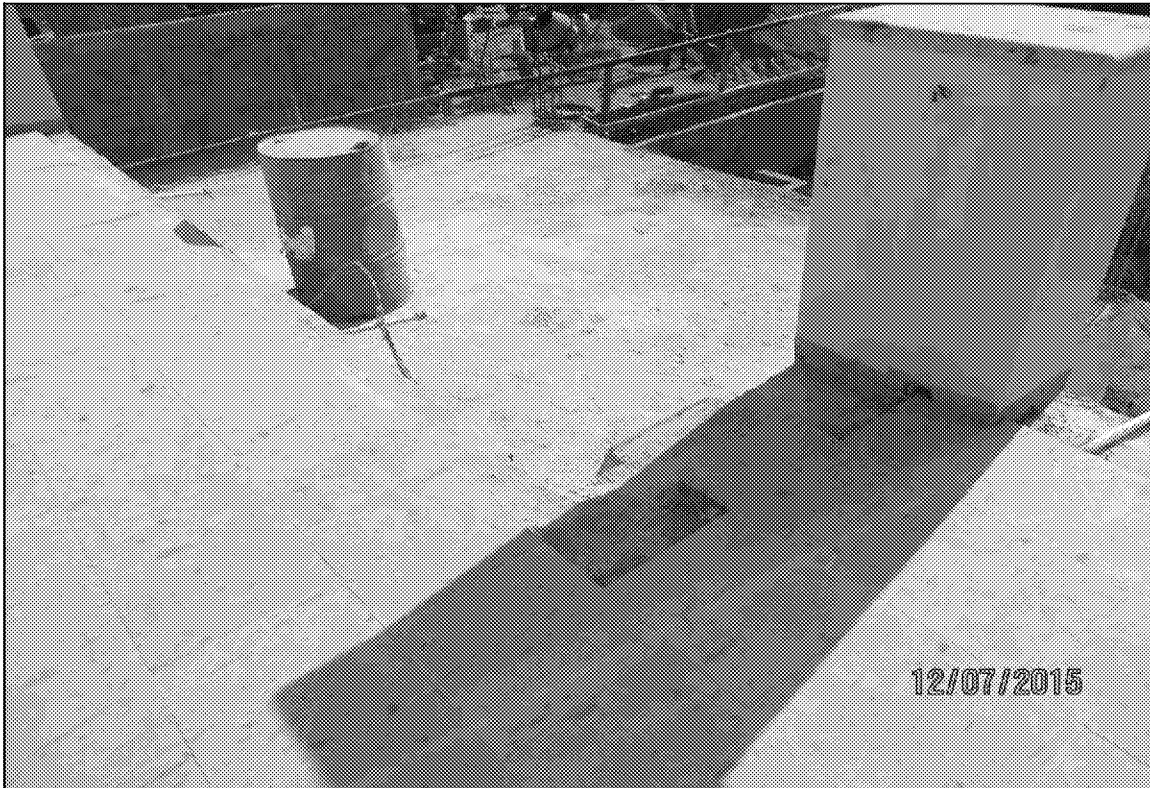
**Photograph 42:** GV 27: Construction of the Jacuzzi tub located at the second floor deck has not begun.

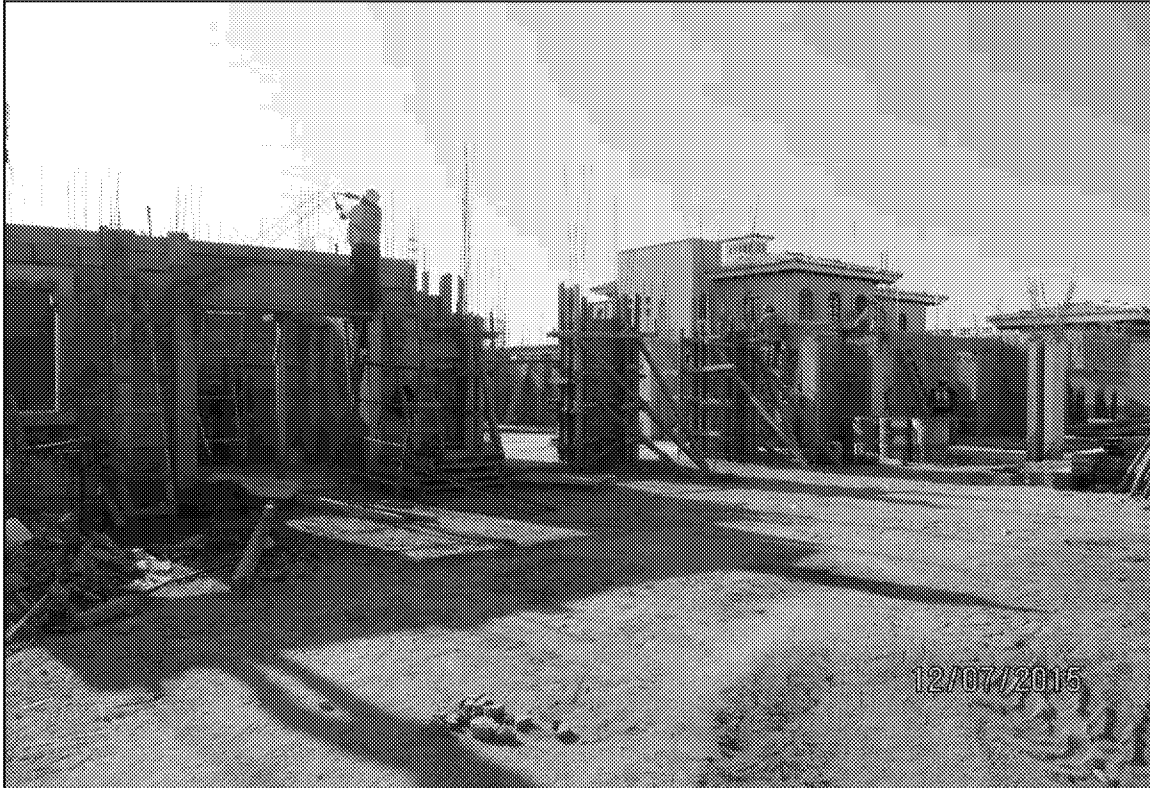
**Photograph 43:** GV 28: The concrete slab on grade is complete and CMU wall construction is underway.

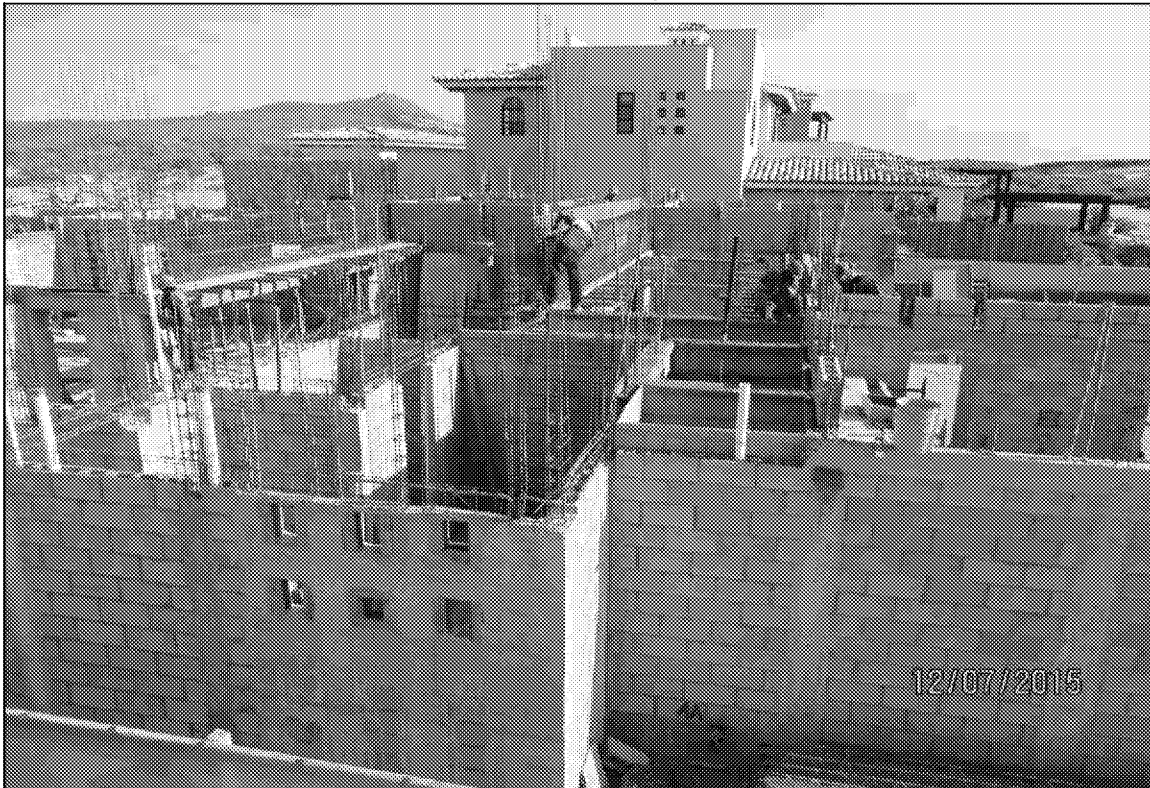
**Photograph 44:** GV 28: The CMU wall construction is up to the ceiling elevation of the 1<sup>st</sup> floor.

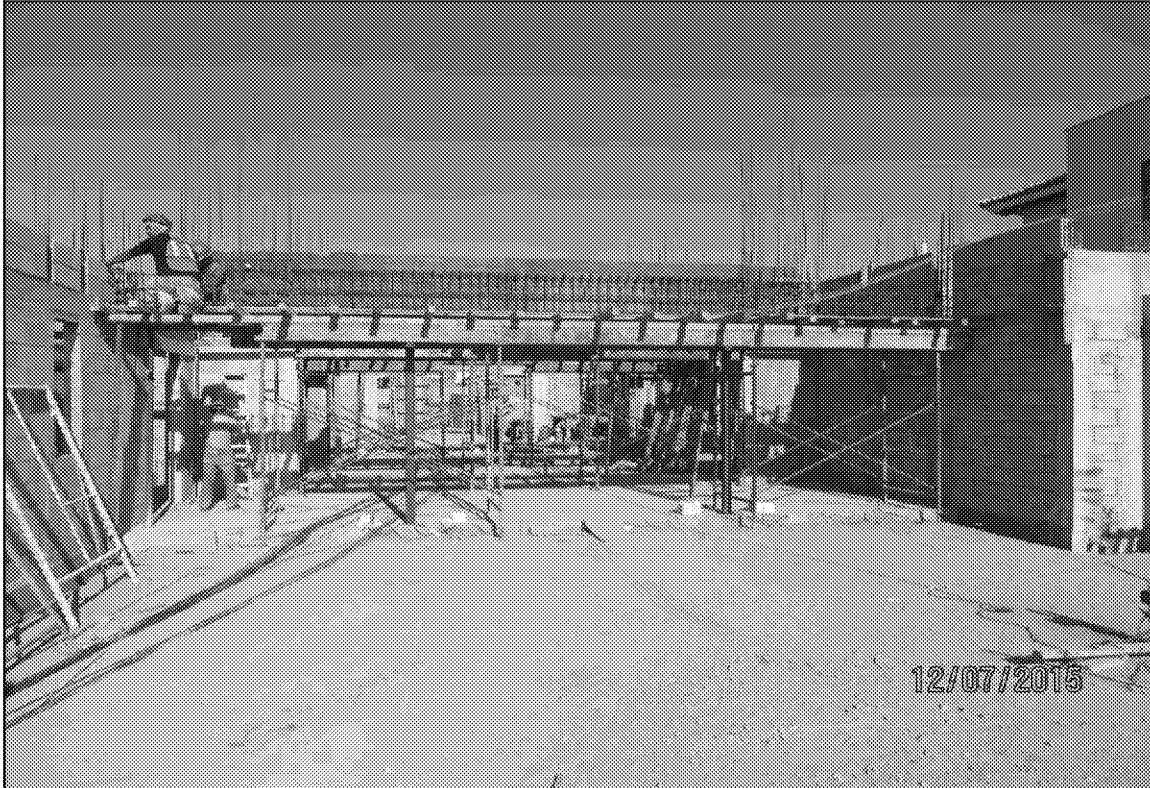
**Photograph 45:** GV 28: Scaffolding is in place and reinforcing steel is being placed for the second floor support beam.

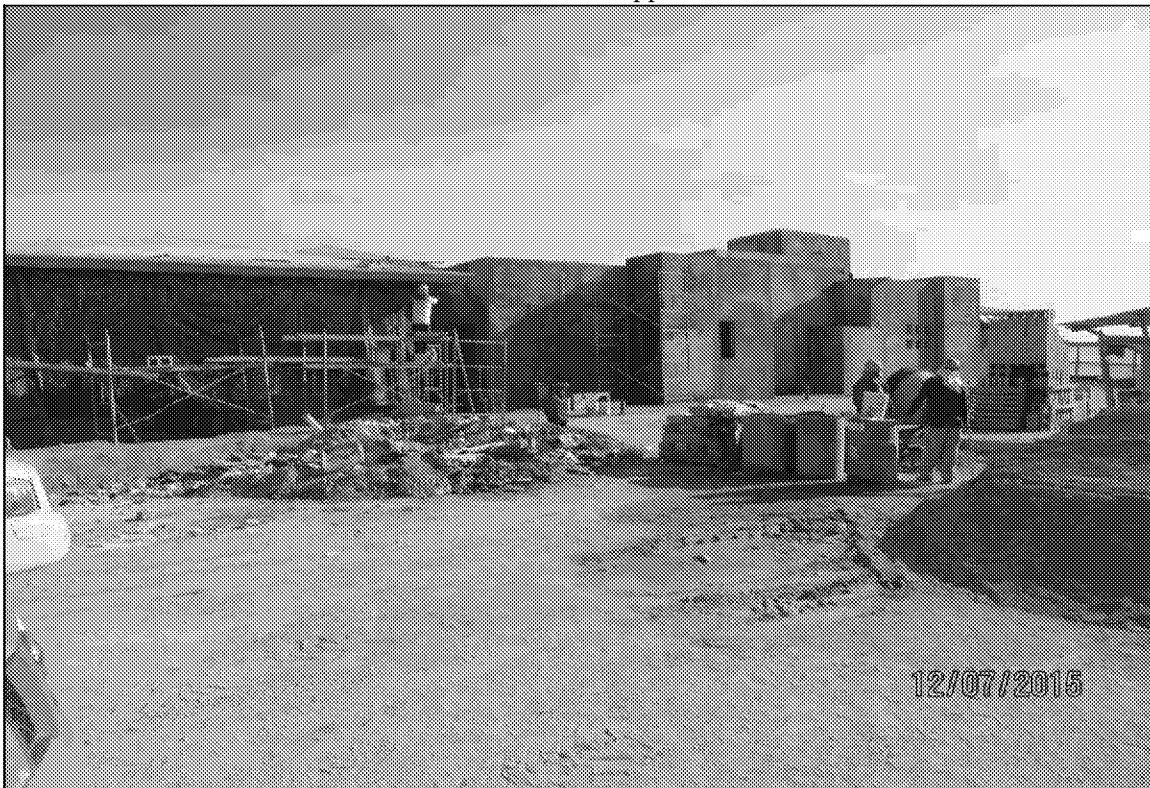
**Photograph 46:** GV 47: Building structure is complete and exterior cement plaster coating is being placed.
